MARK-3[®]

185cc Crankshaft

TECH-NOTE

***** (March 2015) *****

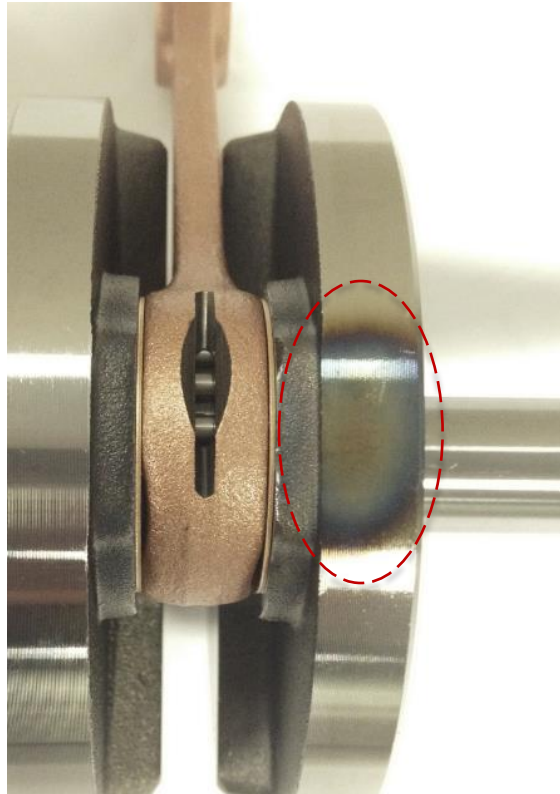
On the current batch of R-341N CRANKSHAFT/CONN. ROD ASSY (801196), a discoloration can be observed on the crank halves:

This heat treatment discoloration is normal and happens during the induction hardening process. The discoloration has **no** **impact** on the crankshaft.

On future batches, an additional surface finishing operation will be added to remove the discoloration.

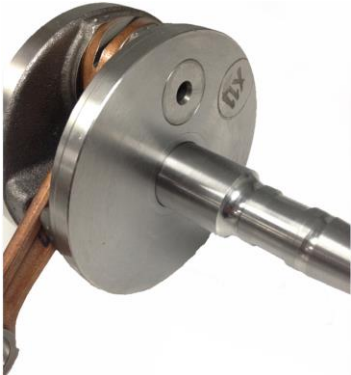
<p style="text-align: center; margin-top: 5px;">Output shaft pressed into crank web</p>

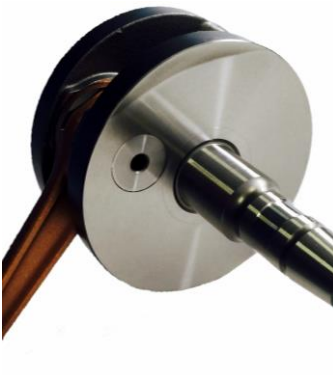
<p style="text-align: center; margin-top: 5px;">Output shaft machined from crank web forging</p>
