MARK-3[®]

185cc Crankshaft

TECH-NOTE

***** (March 2015) *****

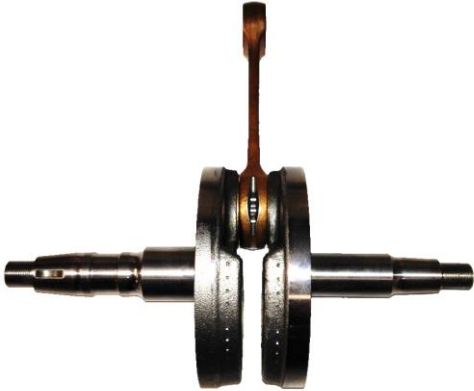
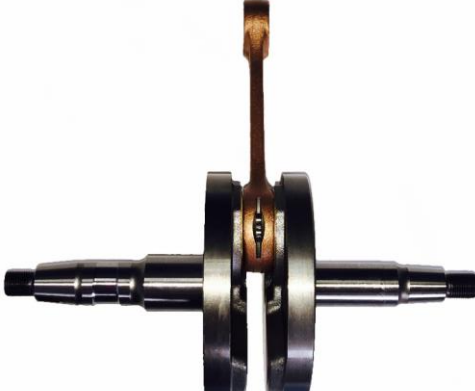
R-341 CRANKSHAFT/CONN. ROD ASSY (800027)	R-341N CRANKSHAFT/CONN. ROD ASSY (801196)

Item R-341 Crankshaft/Conn. Rod Assy (800027) will be replaced by item R-341N Crankshaft/Conn. Rod Assy (801196). The R-341N crankshaft is fully compatible and retrofitable with both CDI and POINT ignition engines. The main difference between the two crankshafts is that the output shaft is no longer pressed into the crank web; it is now machined from the same forging.

<p style="text-align: center; margin-top: 5px;">Output shaft pressed into crank web</p>
